Manhole Inspection Summary

Manhole # S35SS_023MH

Insp Date: 1/19/07 1:34 PM

Location Address: **2643 27TH ST**

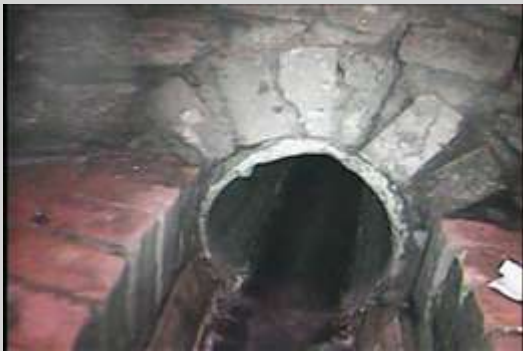
8 in. Circular Gravity Sewer Pipe In @ 9 O'Clock

Pipe Material: **Clay** ☐ Pipe Lined

Infiltration: **None** Pipe Seal Cond: **Unknown**
